MAAP #33: Illegal Gold Mining Alters Course of Malinowski River (border of Tambopata National Reserve)

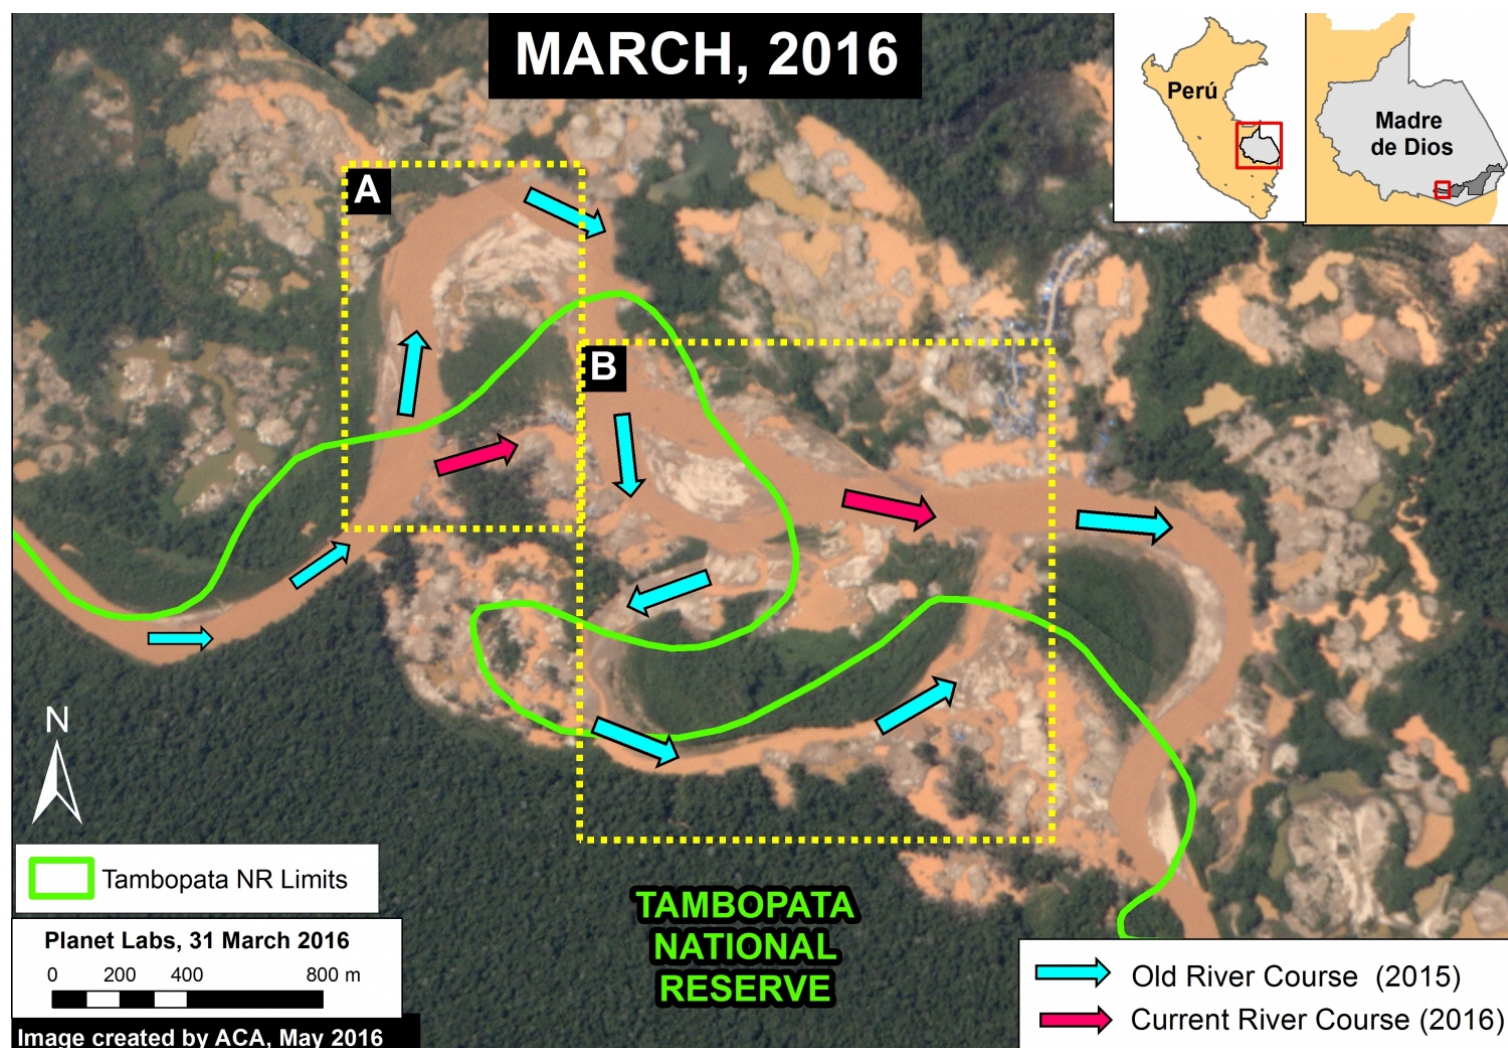
Image 33a. Data: Planet Labs, SERNANP

In [MAAP #30](#), we described the illegal gold mining invasion of Tambopata National Reserve, an important protected area in the southern Peruvian Amazon (department of Madre de Dios). Here in **MAAP #33**, we show that illegal gold mining is also **altering the course of the Malinowski River**, which forms the natural boundary of the Reserve. **Image 33a** shows the two areas where we have documented a total **artificial deviation (cutting) of 4.4 km (2.7 miles)** of the river (see details below).

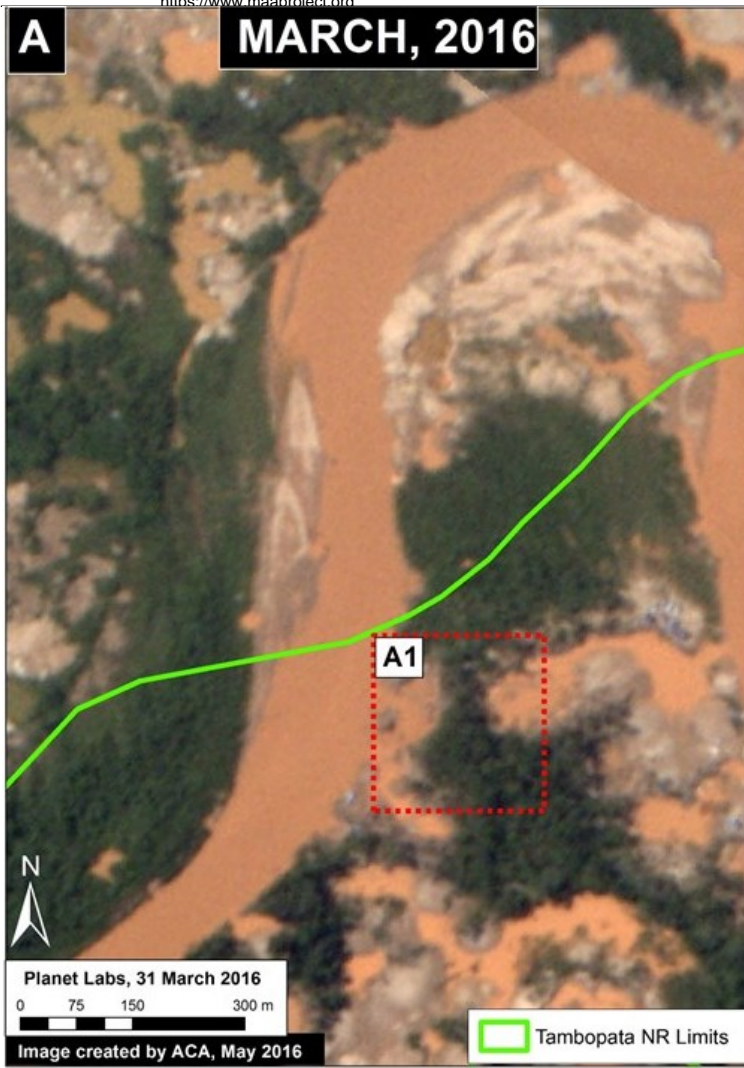
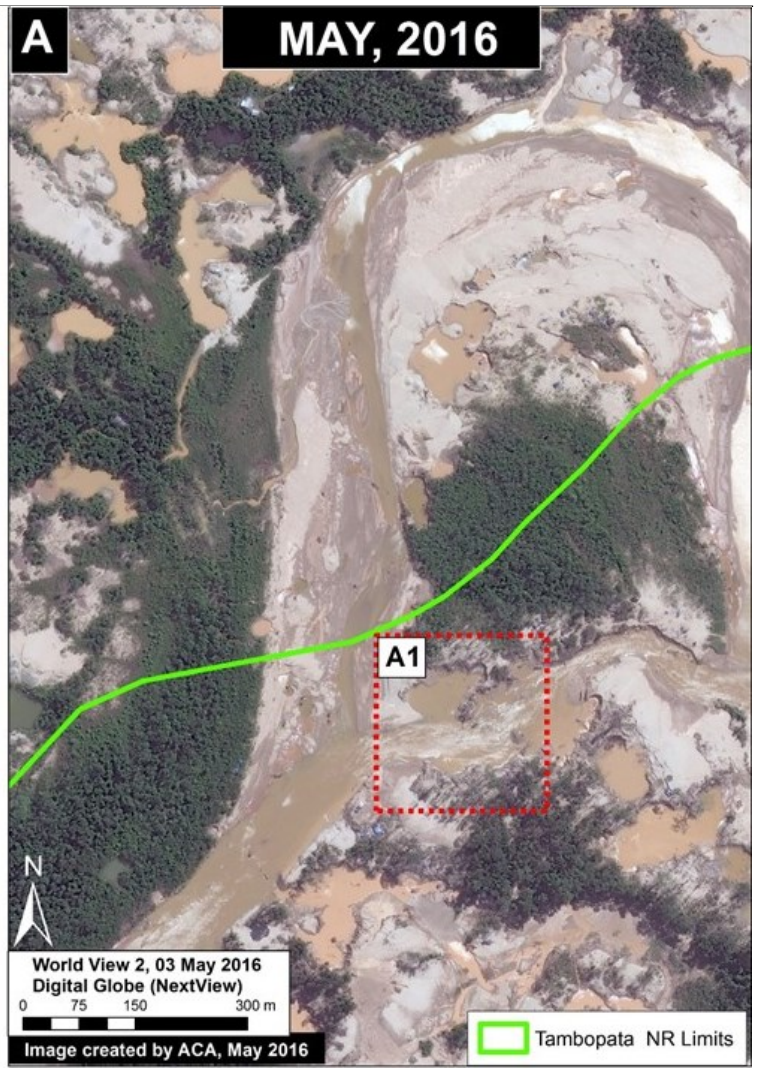
Image 33b. Data: Planet Labs, Digital Globe (Nextview)

Image 33b shows the final stage of the deviation of the Malinowski River between March 31 (left panel) and May 3 (right panel) of this year in the area indicated by Inset A in Image 33a. The new flow of the river is clearly seen in the right panel, **cutting a 1.7 km stretch** of the previous course.

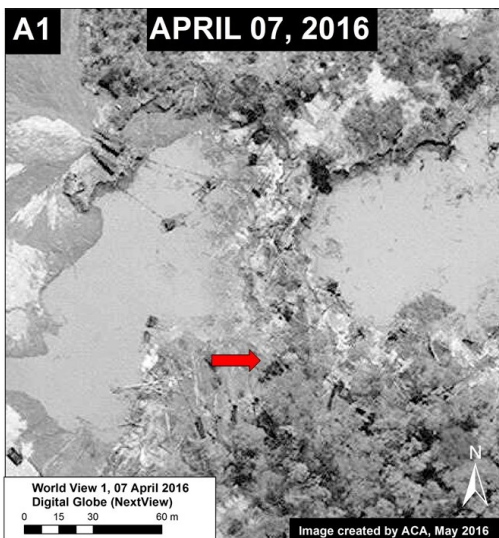
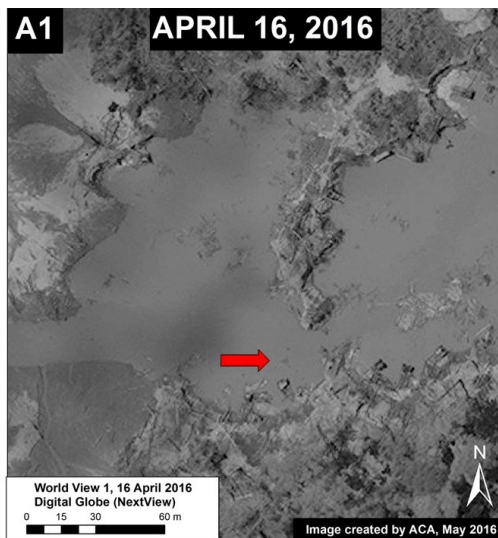
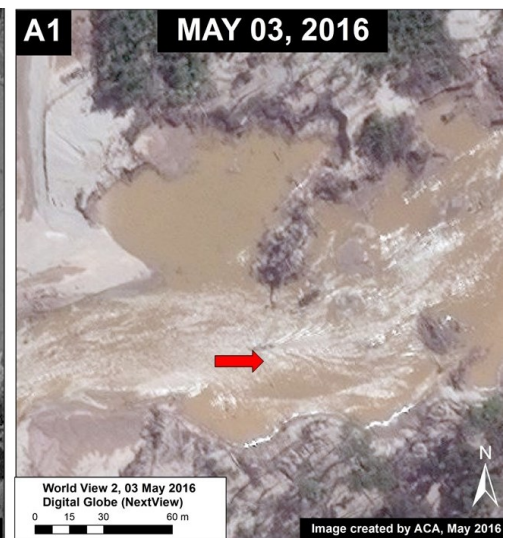
Image 33c. Data: Digital Globe (Nextview)

Image 33c shows with greater precision how the Malinowski river was diverted in this area between April and May 2016. The red arrow indicates the exact same place across time in the three images.

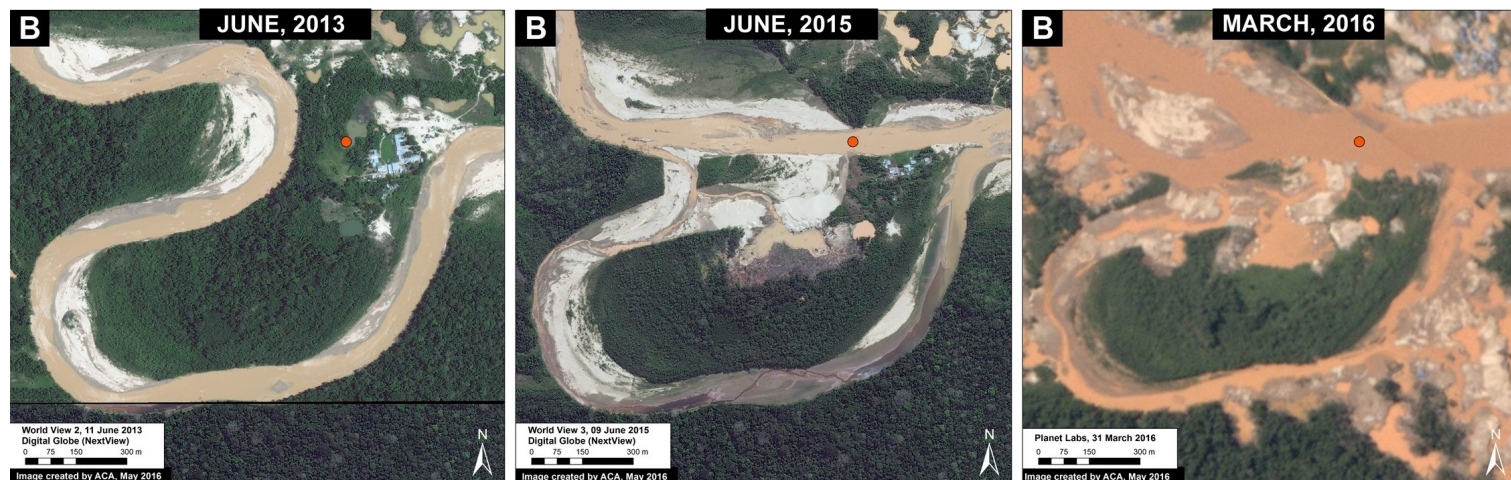
Image 33d. Data: Digital Globe (Nextview), Planet Labs

In February 2016, Peruvian specialists presented how mining activity had recently changed the natural course of the Malinowski river in the area indicated in Inset B*. **Image 33d** shows the **progressive change**: from the increase in mining activity along the normal course of the river in June 2013 (left panel), to the new stretch of riverbed in June 2015 (center panel), and finally to the expansion of mining activity along the previous course (right panel). The red dot indicates the same place over time in the three images. A total of **2.7 km was cut** from the previous river course.

- As seen in Image 33d, fish access to certain areas will be interrupted by the blockade and closure of channels. Also, the connection between the floodable forest and the river channel is completely altered, if not interrupted, in this section of the river. Many fish species that eat fruit or vegetation from the adjacent forest depend on this seasonal connection for food.
